2 BEAR GAP NO. 6

4 PHASE I INSPECTION REPORT

1 NATIONAL DAM INSPECTION PROGRAM

15
DACW32-78-C-0044
Prepared For
DEPARTMENT OF THE ARMY
Baltimore District, Corps of Engineers
Baltimore, Maryland

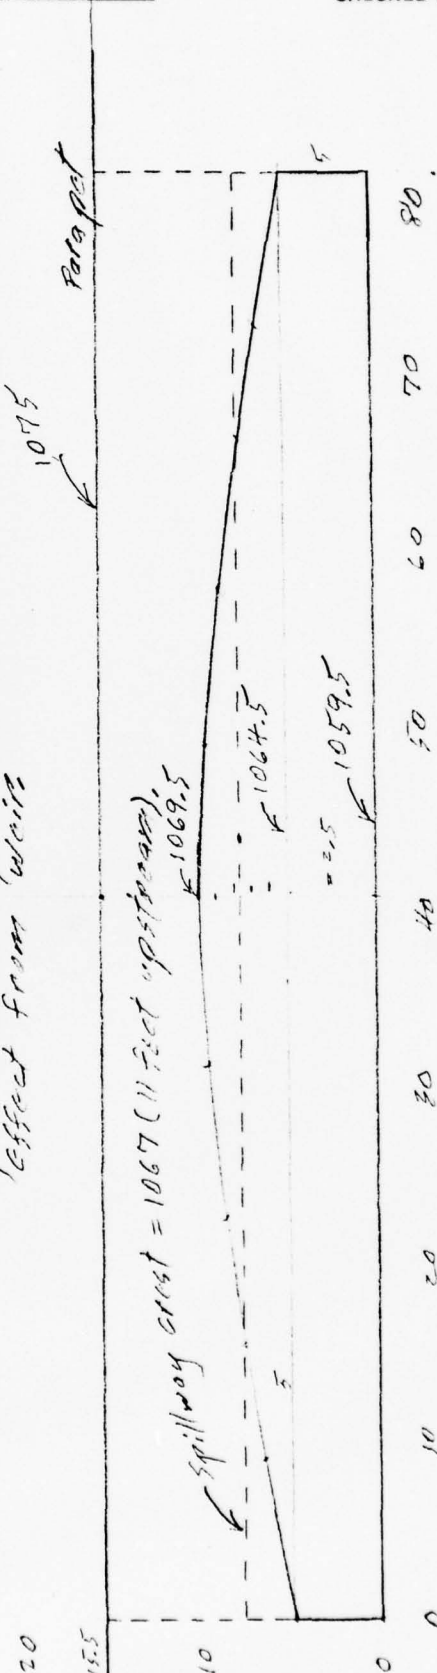
SECTION AT
 STONE ARCH BRIDGE

Visual observations indicate no present stability or stress problems in any of the appurtenant structures. A small amount of spalling has occurred on the spillway walls near the spring line of the arch bridge.

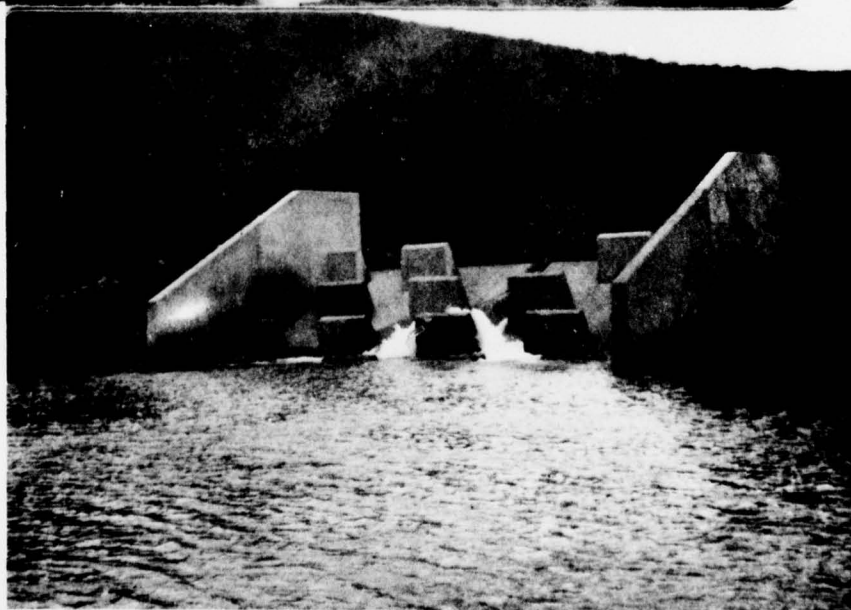
End of
Spillway

The appurtenant structures all appear to be in good condition. An arch bridge is located across the spillway just below the ogee section (Appendix D, Plate IV). The spillway had been heavily damaged during tropical storm Agnes in June, 1972. The damage started about 200 feet downstream from the ogee section. The spillway chute was redesigned and construction was completed in 1975. Photographs on Plate IV and V show the new spillway channel and energy dissipators.
